1985 HURRICANES: JUAN DANNY ELENA(U) RED RIVER BASIN
COORDINATING COMMITTEE NEW ORLEANS LA MAY 87

MAY 1987

US Army Corps
of Engineers
New Orleans District

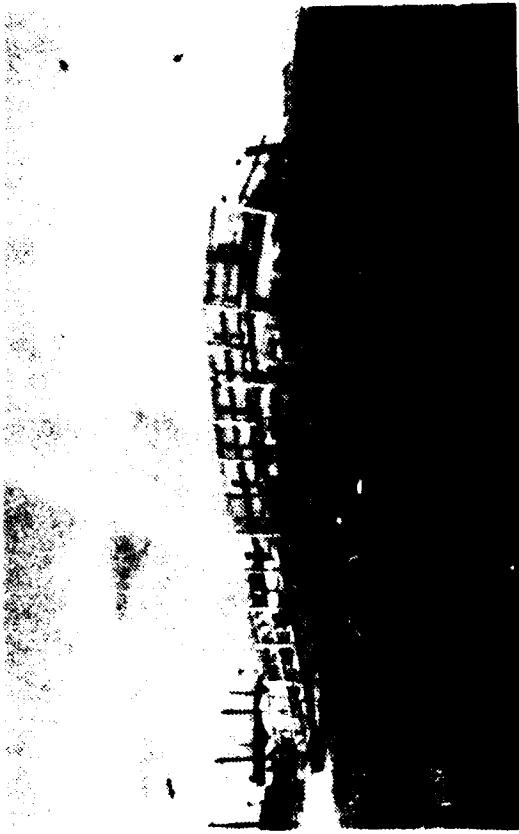
Intact pedestrian crossover at
Grand Isle

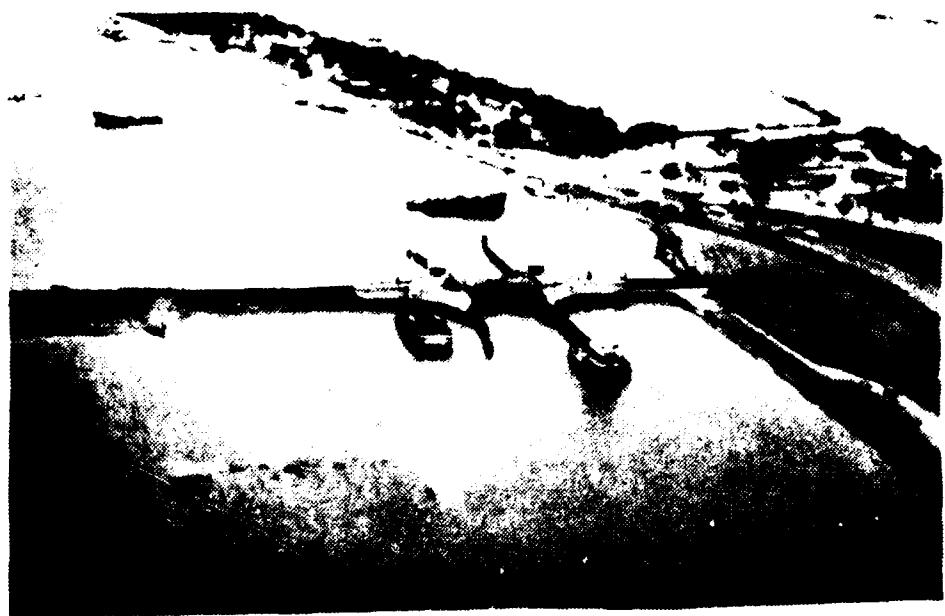
Golden Meadow Floodgate in
Lafourche Parish

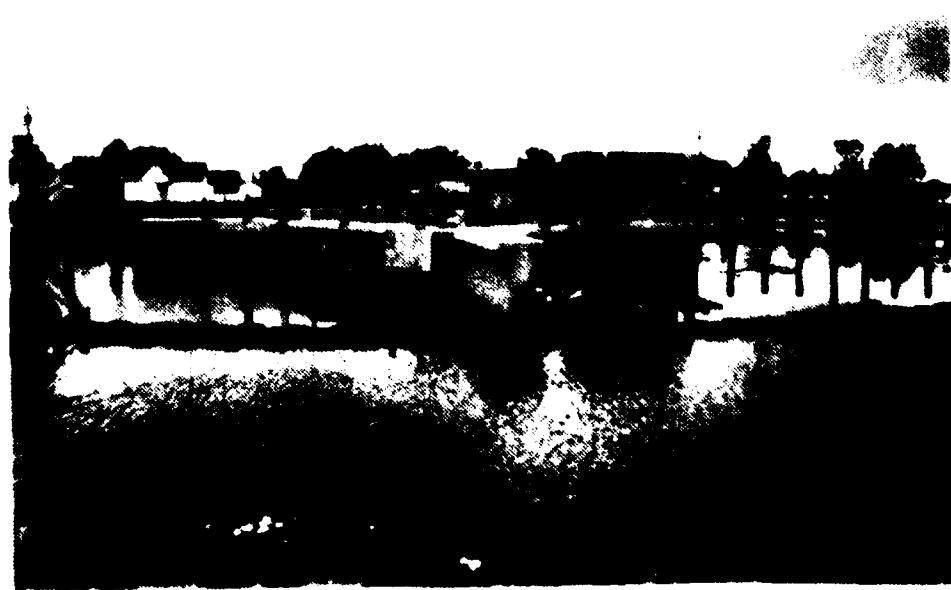
Larose Floodgate Under Construction
in Lafourche Parish

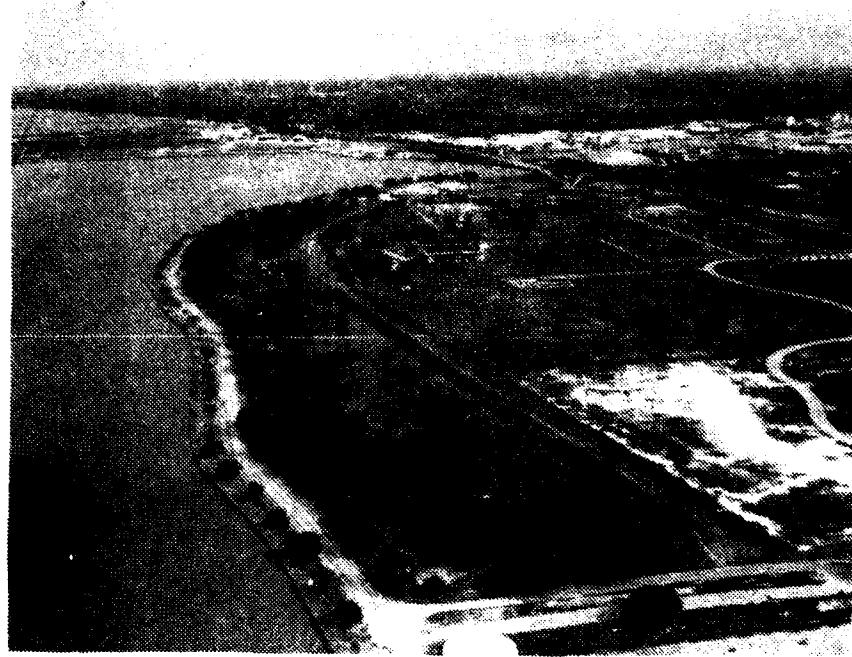
Lake Pontchartrain near IHNC in
Orleans Parish

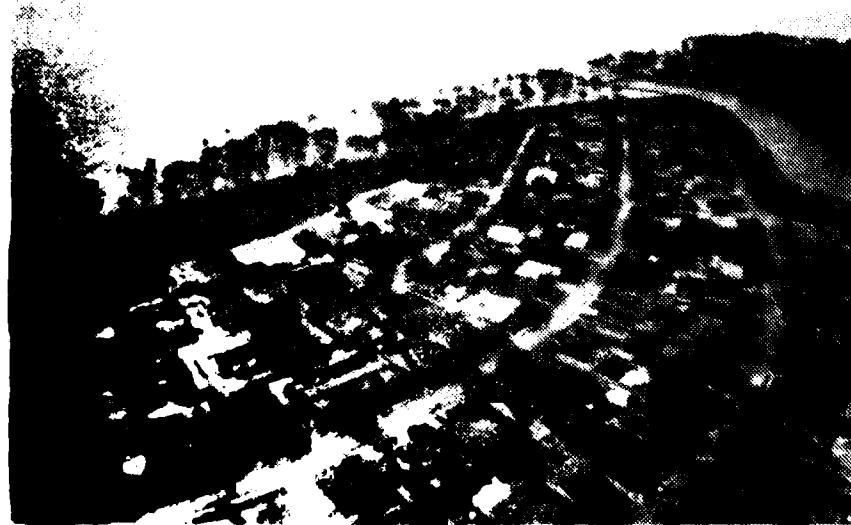
Lake Pontchartrain near Orleans Canal
